The Application of Risk-based Drinking-water Source protection and an ArcGIS platform for Integrated Catchment Management to Deliver Improved Water Safety Planning and Public Health Outcomes in the Pacific Islands

12th Pacific Water and Wastewater Conference & Expo, Warwick le Lagon,
Port Vila, Vanuatu 5-9 August 2019

Tony Cussins, Principal Consultant – Water Security, Technical Director -
Hydrogeology, Tonkin + Taylor International Ltd

The Havelock North outbreak

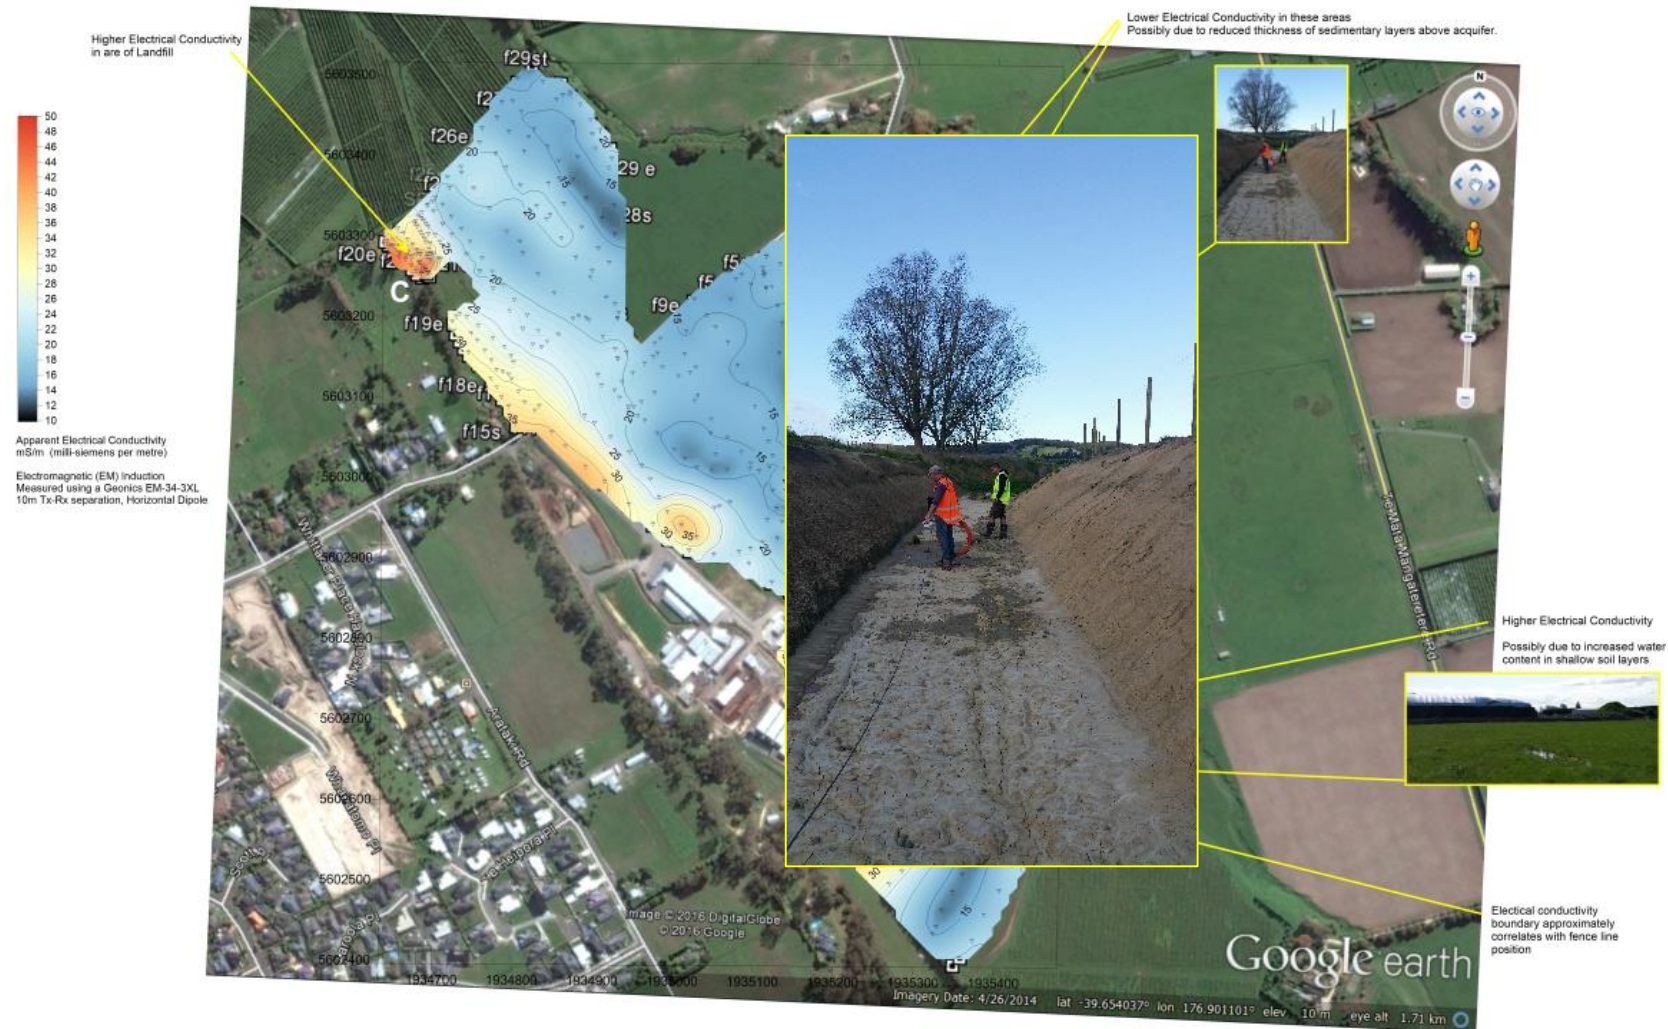
Figure 3

Apparent Conductivity Map (Average values for 0-10m depth range)
Measured using Electromagnetic Induction (EM-34)

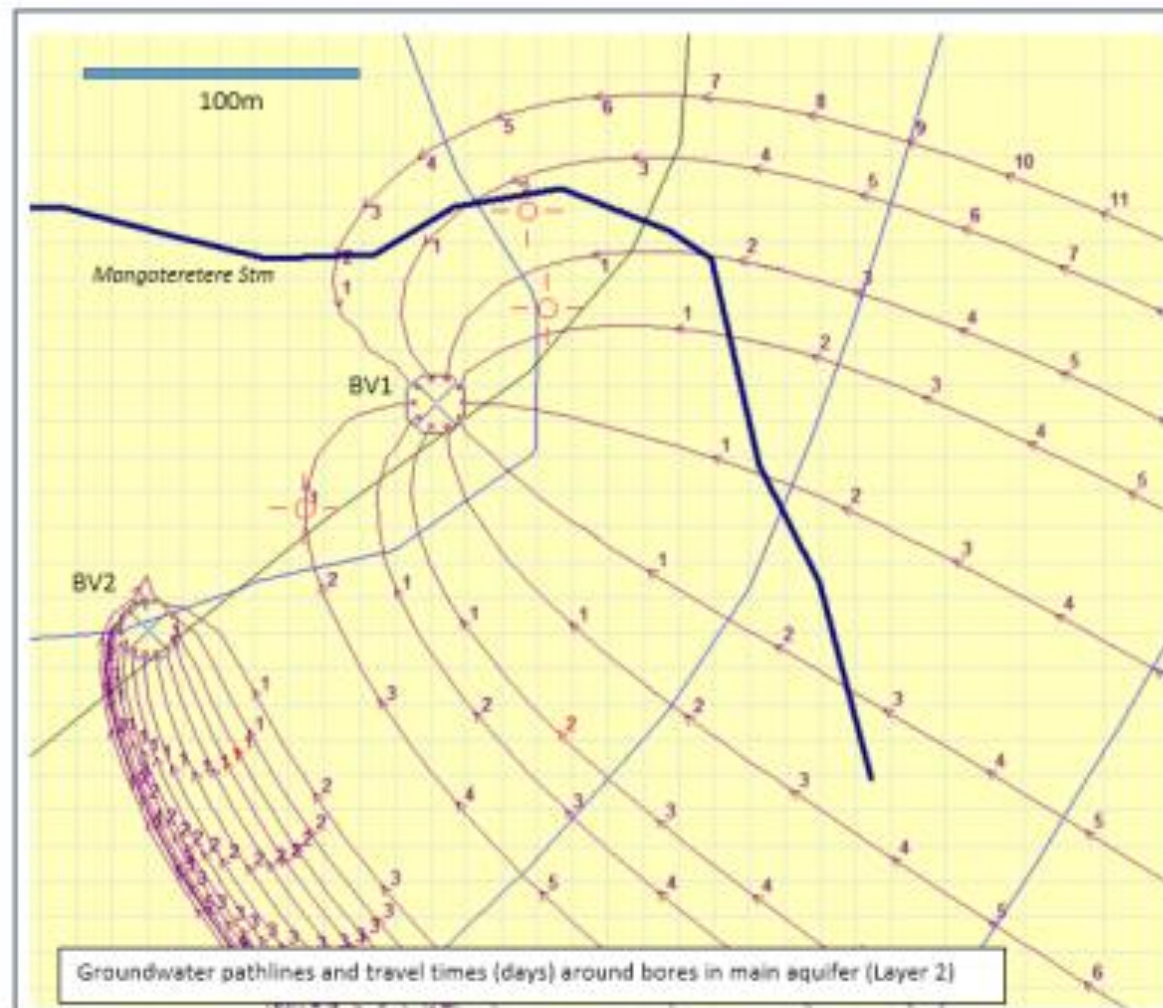
Figure 16: Simulated path lines and captures zones and travel times for BV1 and BV2 using an effective porosity of 0.02. BV 1 pumping at 90 L/sec, BV2 pumping at 15 L/sec.

- Groundwater numerical modelling using MODFLOW and MODPATH
- Modelling results indicated a 1-2 day travel time between the Mangateretere Stream and Bore 1
- Contaminant fate & transport indicated *Campylobacter* survival in groundwater
- Viability supported by ESR (Dr Brent Gilpin)

Key question: “Could *viable* pathogenic micro-organisms have travelled from the Mangateretere Stream ponded area to Bore 1?”:

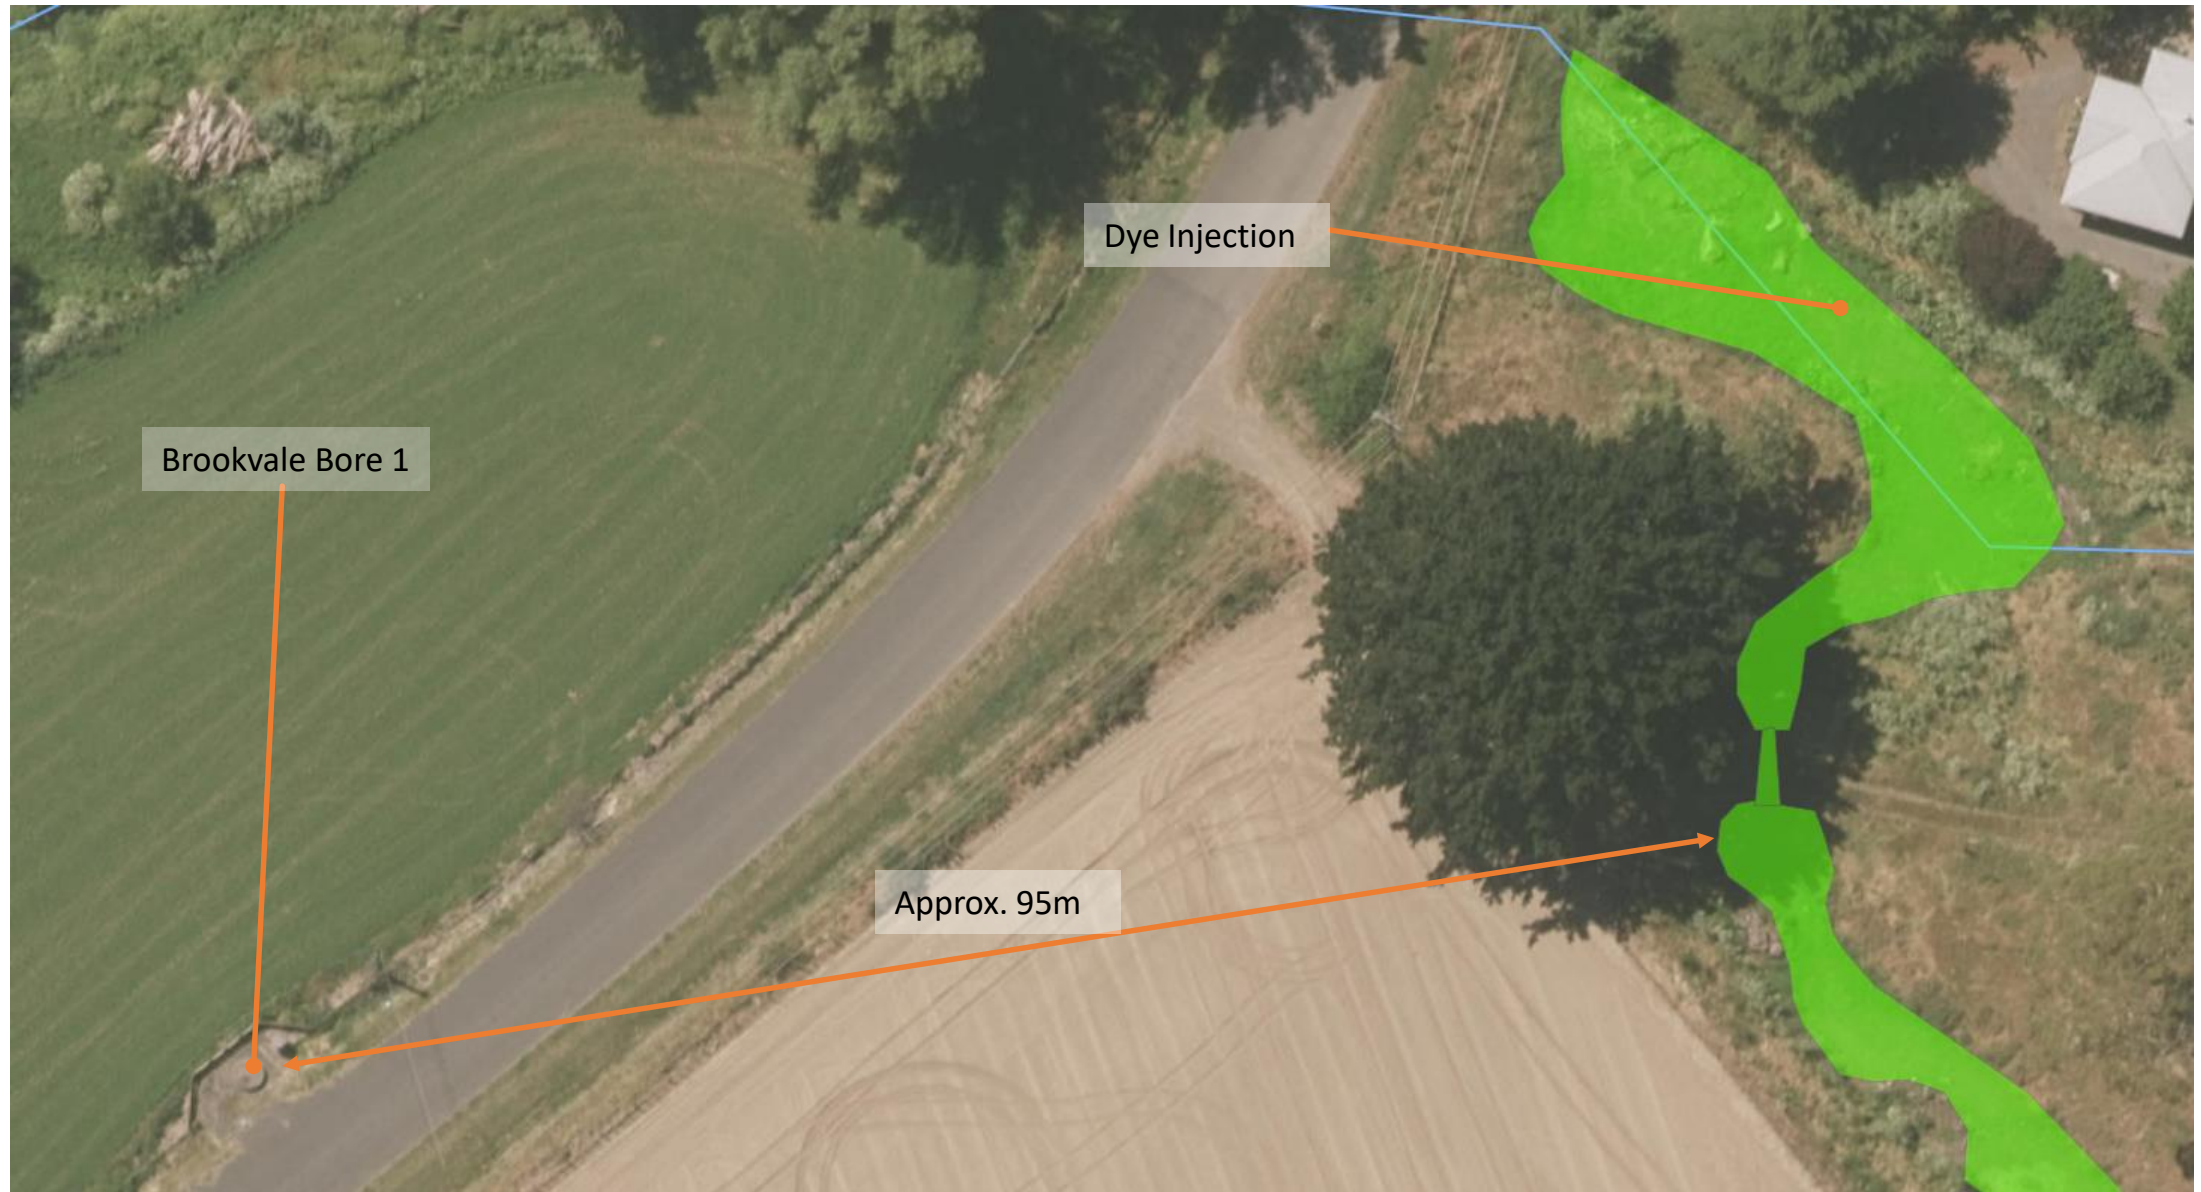
Results of dye tracer tests

Fluorescein dye first appeared in Bore 1 approximately 29 hours after injection into the Mangateretere pond

Strongly supported by contaminant data, including:

- *E.coli*
- *Campylobacter*
- *Total coliforms*
- O157:H7 pathogenic *E.coli* strain in pond

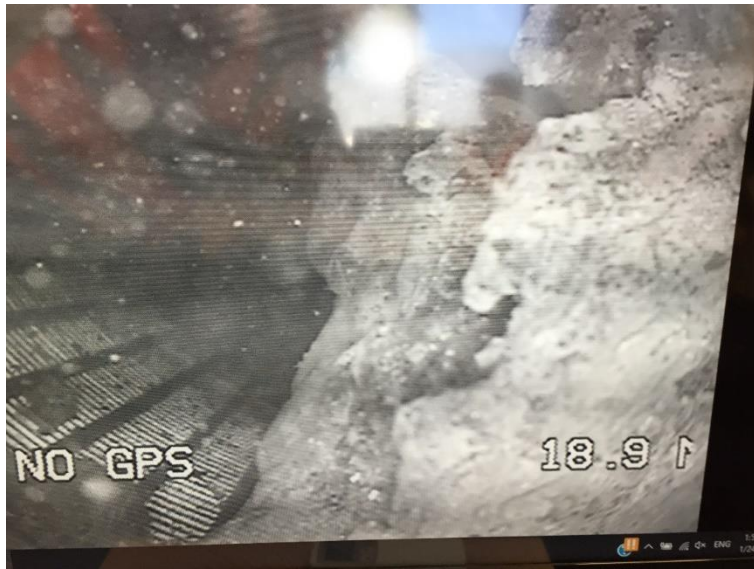
Bore / casing assessments

High level float switch operation, casing integrity, downhole geophysics demonstrated casing integrity

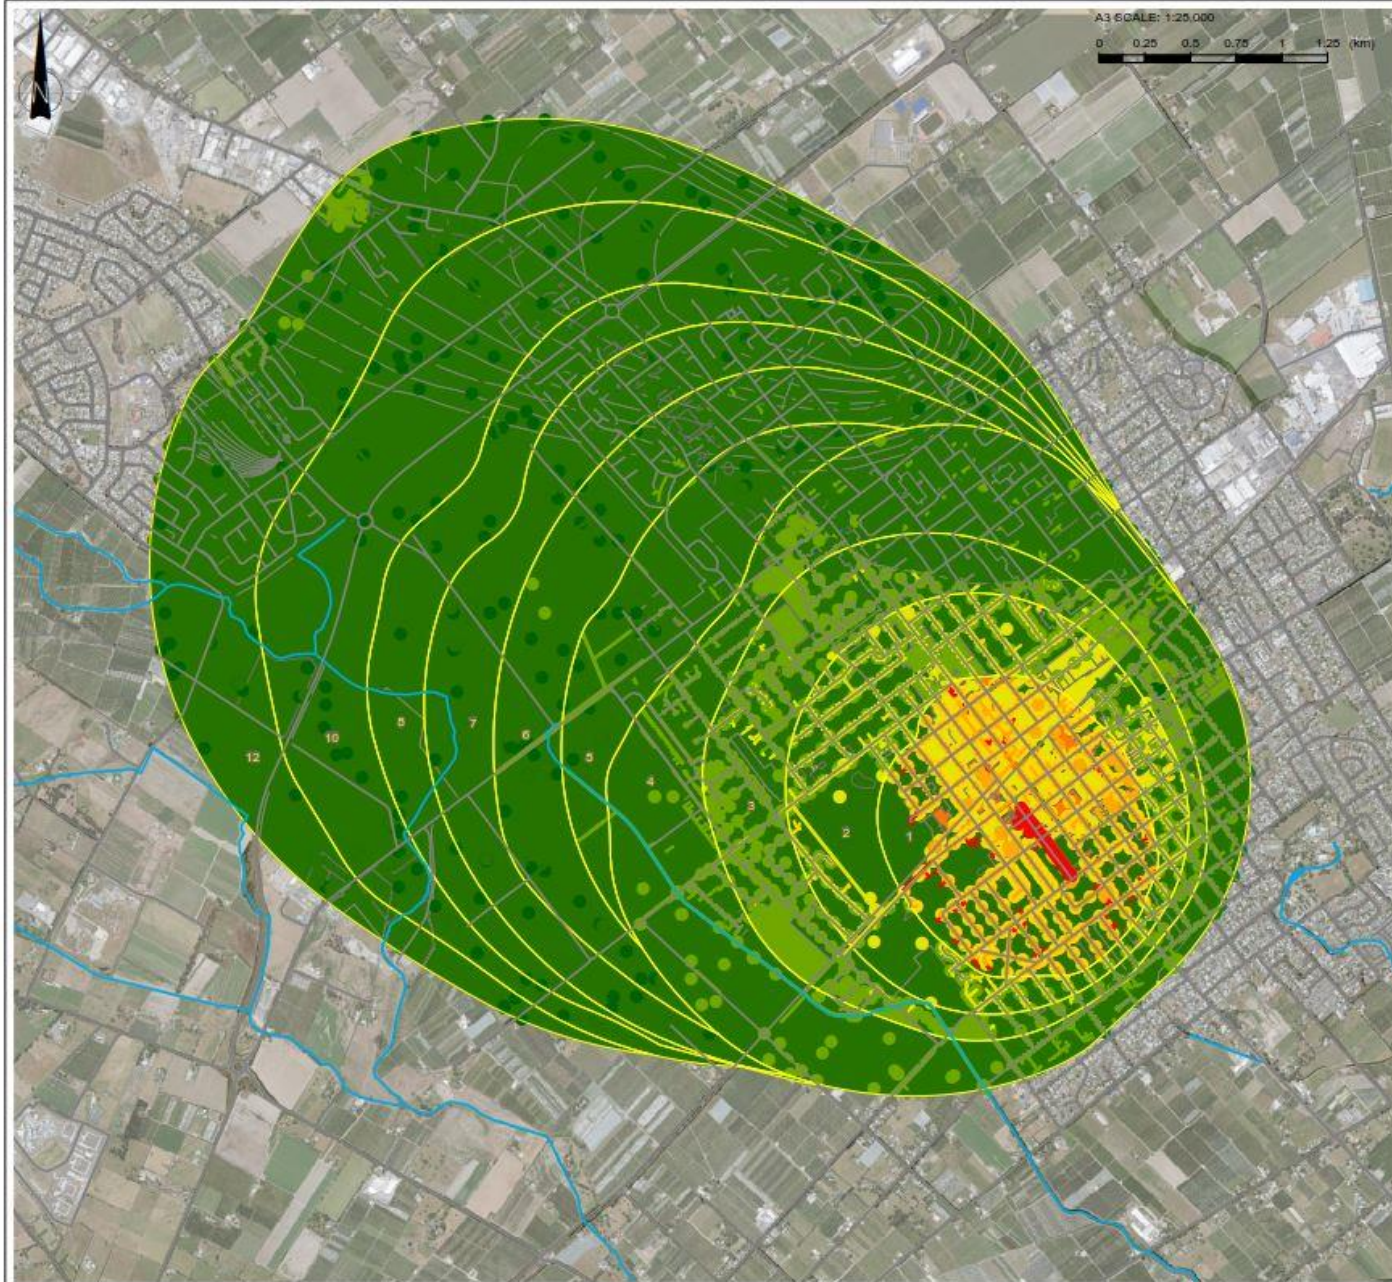
Figure 1

Eastbourne Bore Field Risk Mapping

Combined Risk

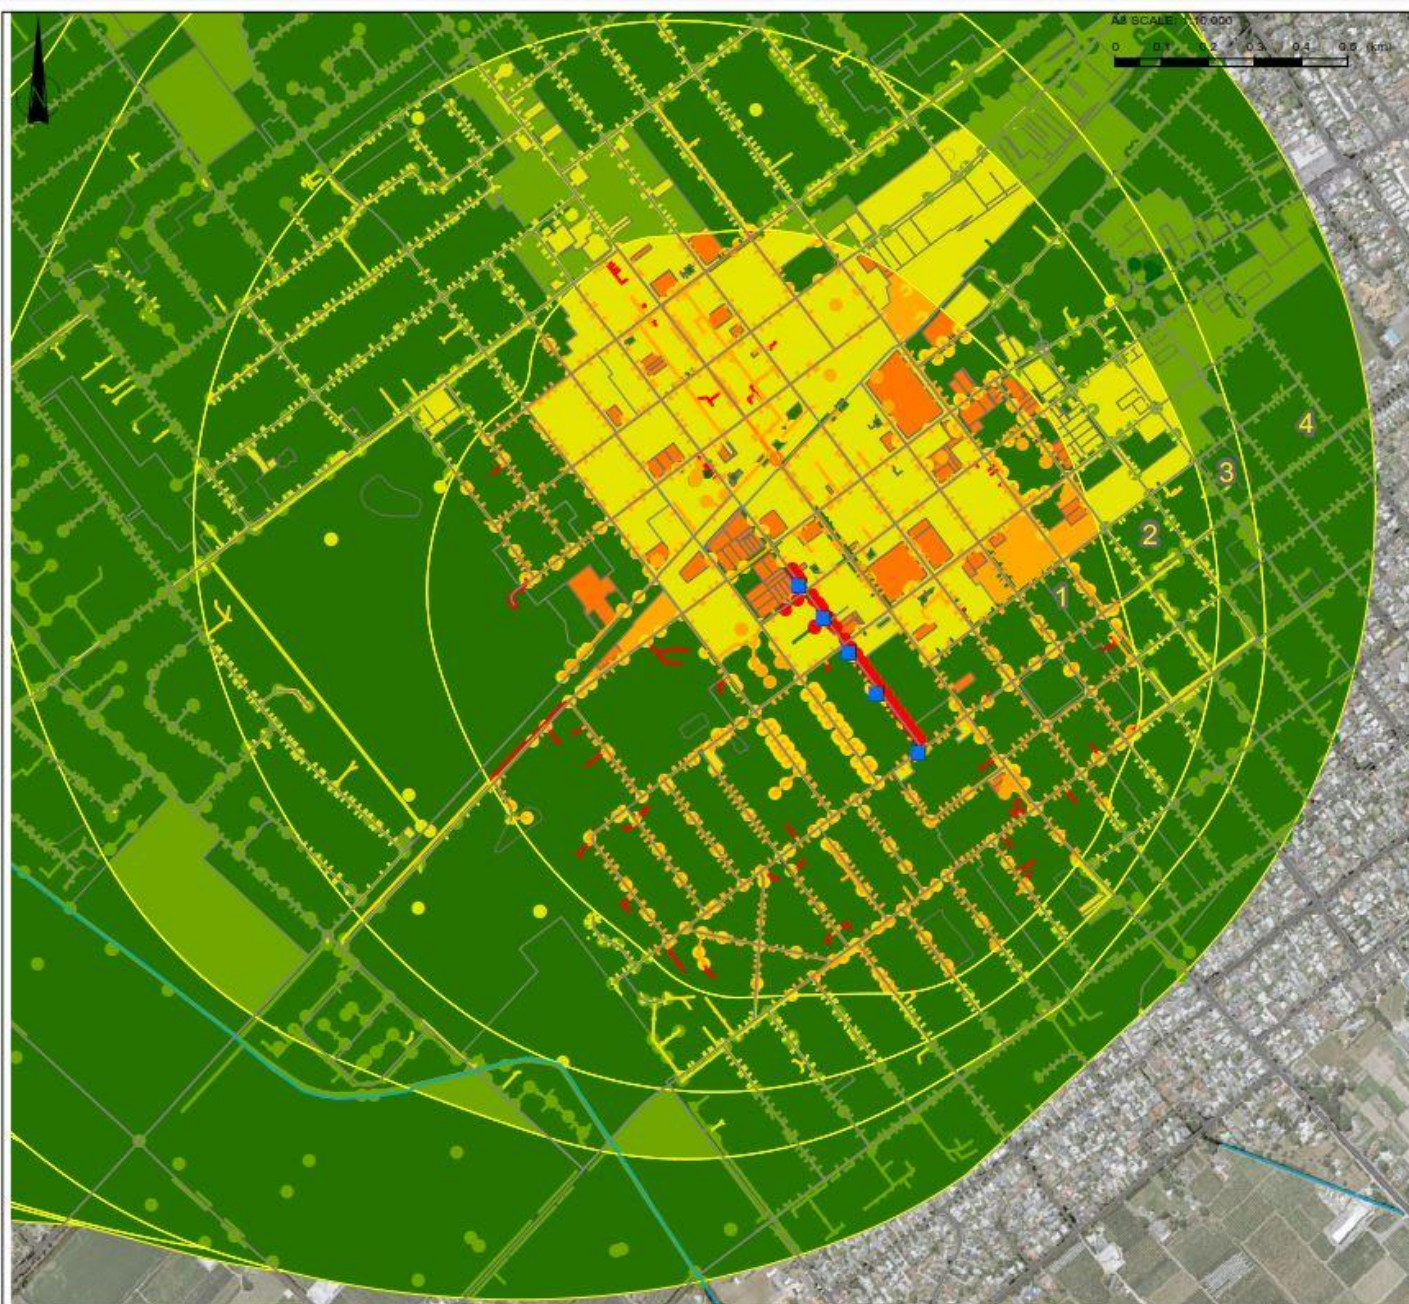
Figure 2

Catchment Sanitary Investigation:
Eastbourne Bore Field Risk Mapping
Combined Risk
